Ultrasonographic and Radiographic Findings of Polyethylene Component Displacement with Severe Metallosis and Metal-Induced Synovitis Following Total Knee Arthroplasty

Abstract

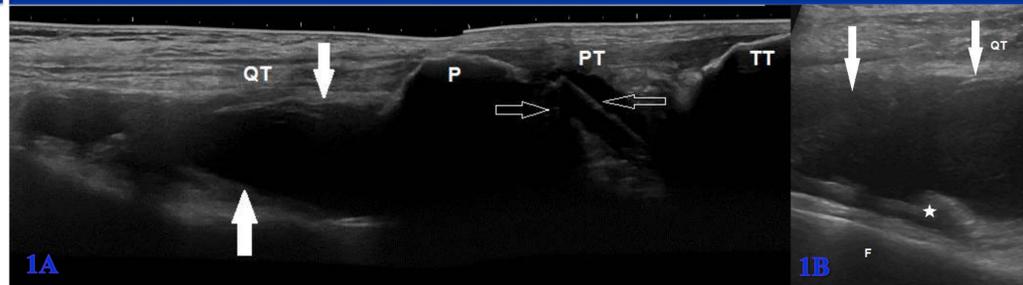
The patient was then referred for a diagnostic US of the right knee. Ultrasonographic imaging with a 10-MHz transducer (GE LOGIQ E9; General Electric Company, Chicago, IL) demonstrated severe, echogenic, shadowing, and incompletely compressible distention of the suprapatellar recess consistent with severe metal-induced synovitis in combination with a complex joint effusion (Fig. 1). US imaging also demonstrated the anteriorly displaced polyethylene component as an obliquely oriented linear echogenicity extending anteriorly into Hoffa's fat pad, inferior to the patella and adjacent to the patellar tendon (Fig. 1). Color Doppler imaging failed to demonstrate hyperemia confirming the chronicity of this finding.

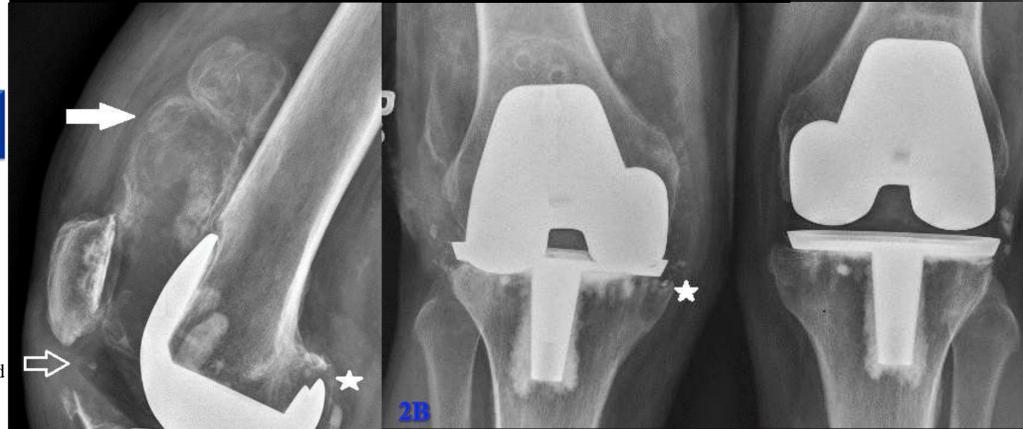
Radiographs were obtained which demonstrated significant dense distention of the suprapatellar recess with anterior displacement of the polyethylene component resulting in metal-on-metal articulation (Fig. 2).

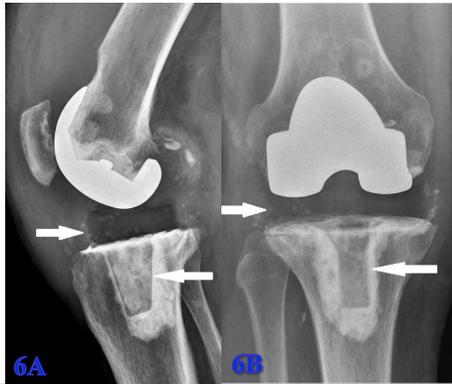
Figure 6. Radiographs obtained following the one-stage revision total knee arthroplasty. Anteroposterior (A) and lateral (B) radiographs of the right knee demonstrating a revision right total knee arthroplasty with an all-polyethylene tibial component (arrows).

Subsequently, the patient was scheduled for a one-stage revision total knee arthroplasty. The femoral and tibial components as well as the polyethylene liner were removed. A medial parapatellar arthrotomy was performed, and a large volume of completely black fluid was released from the capsule. The medial and lateral gutters were debrided and a portion sent for culture. Debridement down to native appearing tissue was performed. A synovectomy was performed demonstrating diffuse dark black synovial thickening typical of metallosis with metal-induced synovitis (Fig. 4). Samples from the femur were sent for culture. Fungal, aerobic, and anaerobic cultures were all negative. Macroscopic examination of the retrieved prosthetic components showed severe wearing of the polyethylene liner, most pronounced posteriorly with full-thickness wear involving the underlying tibial modular baseplate and cement (Fig. 5). As shown by US, the outer margins of the lateral part of the liner preserved a normal height (Fig. 1). The one-stage revision total knee arthroplasty was performed using an all-polyethylene tibial component with no modular baseplate (Fig. 6).
