Ultrasonographic and Radiographic Findings of Polyethylene Component Displacement with Severe Metallosis and Metal-Induced Synovitis Following Total Knee Arthroplasty

Abstract

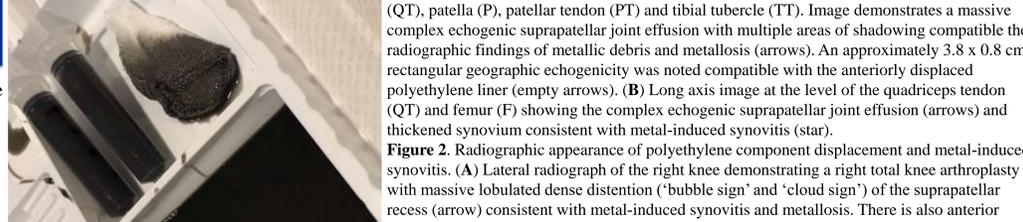
Figure 5. Photographs of the gross specimens obtained during the revision right total knee arthroplasty. (A) Photograph of the removed displaced polyethylene liner demonstrating severe wear, most pronounced posteriorly (arrows) secondary to the anterior displacement and compatible with the radiographic findings. (B) Photograph of the underlying tibial metallic baseplate component with fragmented cement and black synovial tissue. Severe metallic erosion is noted adjacent to the tip of the surgical probe. (C) Additional photograph of the cleaned tibial component more clearly demonstrating severe metallic erosion and metal loss along the posterior aspect (side against the blue surgical cloth) resulting in metallosis.

Subsequently, the patient was scheduled for a one-stage revision total knee arthroplasty. The femoral and tibial components as well as the polyethylene liner were removed. A medial parapatellar arthrotomy was performed, and a large volume of completely black fluid was released from the capsule. The medial and lateral gutters were debrided and a portion sent for culture. Debridement down to native appearing tissue was performed. A synovectomy was performed demonstrating diffuse dark black synovial thickening typical of metallosis with metal-induced synovitis (Fig. 4). Samples from the femur were sent for culture. Fungal, aerobic, and anaerobic cultures were all negative. Macroscopic examination of the retrieved prosthetic components showed severe wearing of the polyethylene liner, most pronounced posteriorly with full-thickness wear involving the underlying tibial modular baseplate and cement (Fig. 5). As shown by US, the outer margins of the lateral part of the liner preserved a normal height (Fig. 1). The one-stage revision total knee arthroplasty was performed using an all-polyethylene tibial component with no modular baseplate (Fig. 6).
